NIST NCSTAR 1-5A

**Federal Building and Fire Safety Investigation of
the World Trade Center Disaster**

Visual Evidence, Damage Estimates, And Timeline Analysis

William M. Pitts
Kathryn M. Butler
Valentine Junker

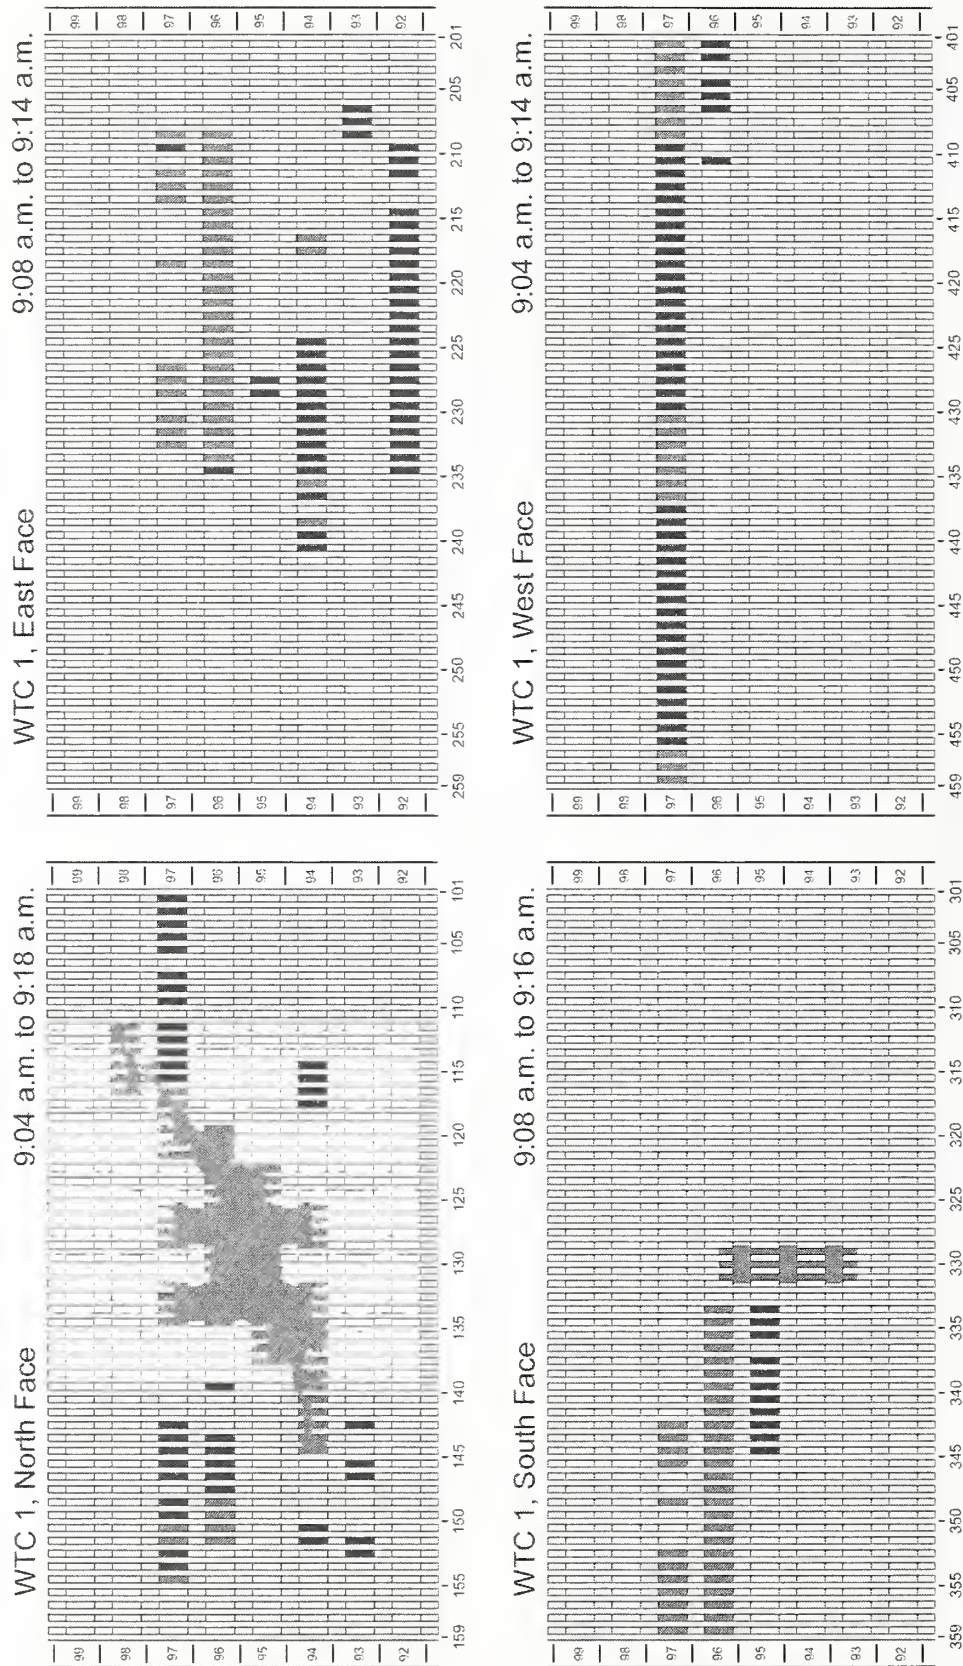
Integrated maps for fire intensity for the period, similar to those shown in Figure 8–14, are included in Figure 8–33. Comparison of these two figures confirms the general trends in fire spread described above. Such a comparison also shows that some of the fires observed during the initial period have died down and are not apparent during the second time period. Examples include fires on the 97th floor on the north face and areas on the 94th and 97th floors on the east face.

From Figure 8–33 it appears as if the most intense and widespread fires during the period from 9:03 a.m. to 9:18 a.m. were on the 96th and 97th floors. The east side of the tower had the most widespread fires, with flames visible from the 92nd floor to the 97th floor. The absence of burning in the southwest quadrant of the tower is evident from the maps.

Figure 8-33. Maps of integrated fire observations between 9:03 a.m. and 9:18 a.m. are shown for the four faces of WTC 1. Colors represent the highest intensity fire observed in a window using the color scale defined in Figure 5-1.

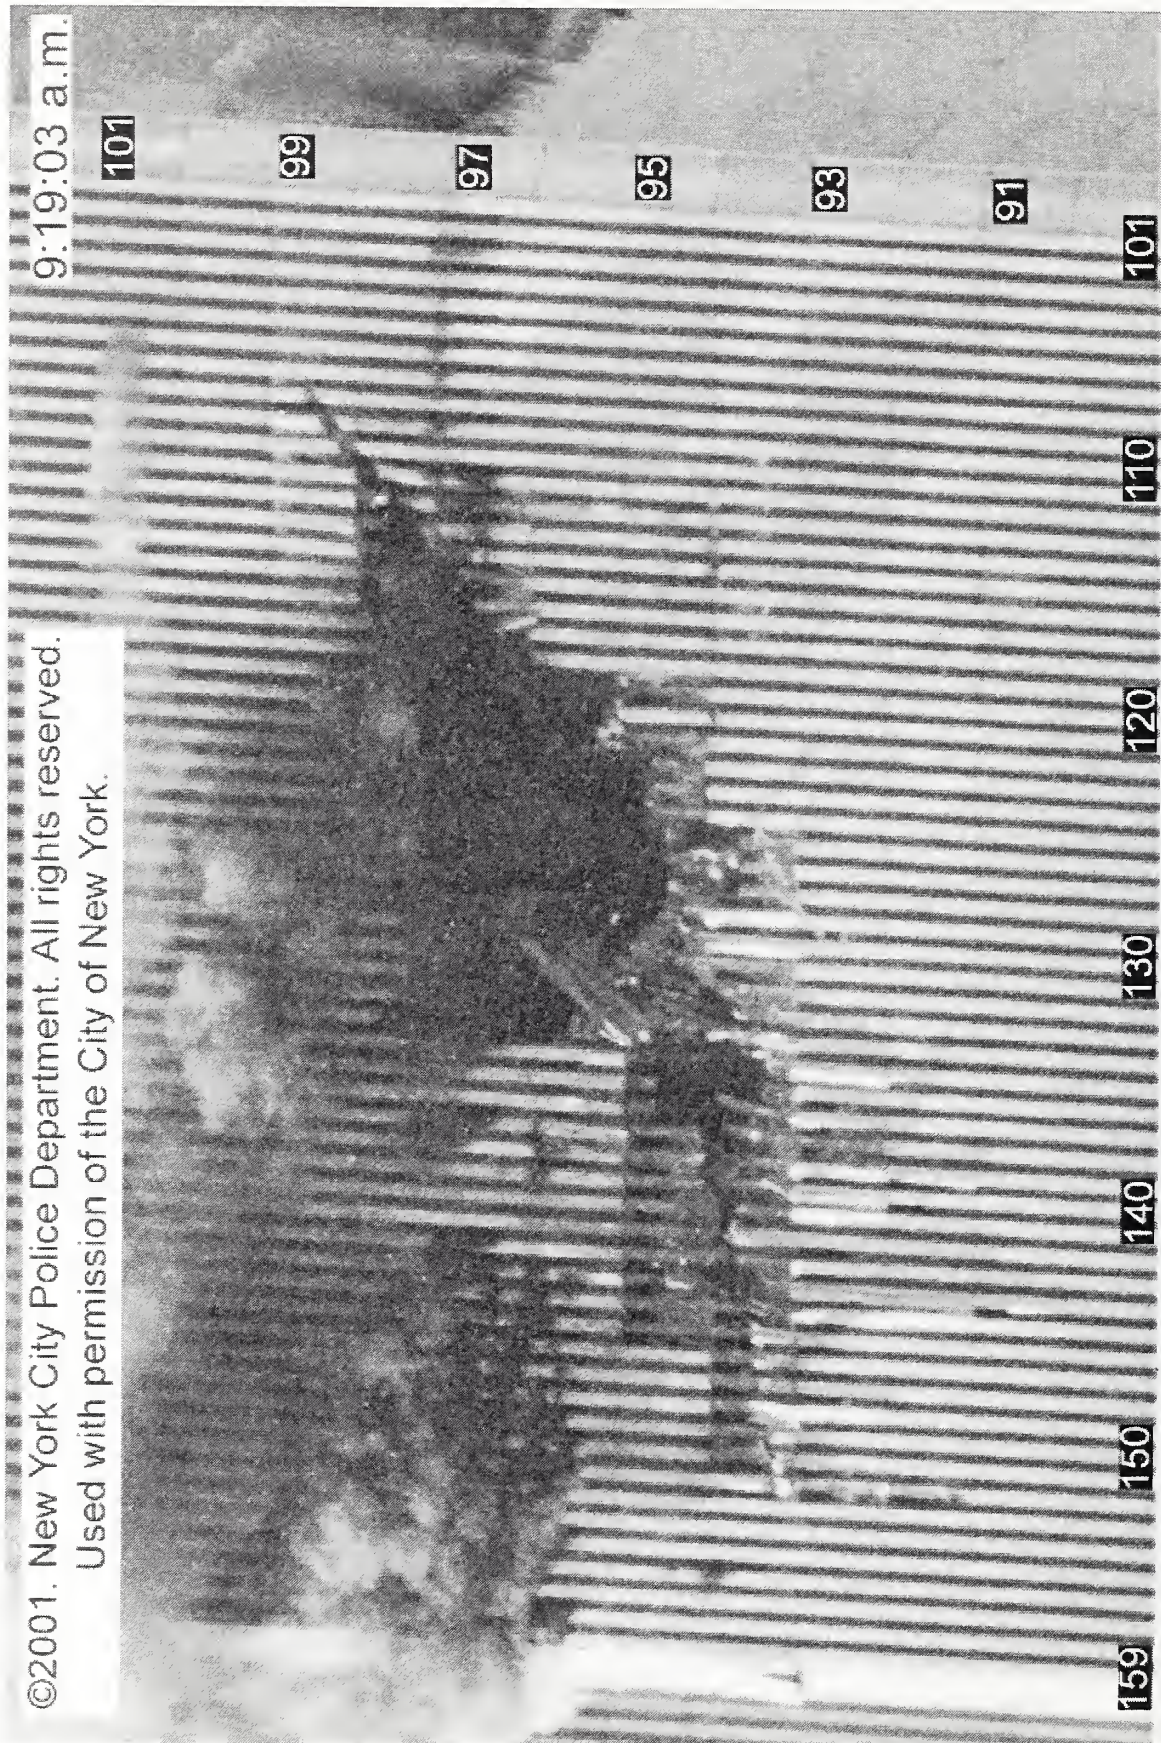
At 9:18:32 a.m. a bright flame appeared in window 94-111, well to the west of the flame present on this floor in Figure 8–19. Fire filled in the length between the two locations during the next 20 s or so. By 9:19:03 a.m. windows from 94-110 to 94-117 were open with flames visible, as seen in Figure 8–34. Note the large number of windows where isolated flames are evident at the tops of the frames in Figure 8–34. Not surprisingly, streamers were observed falling from this region starting at 9:19:42 a.m. Given the amount of fire, there is remarkably little smoke exhausting from the open windows. It is difficult to determine if smoke is flowing elsewhere, but there is no indication of smoke at the 94th floor level from the aircraft impact cavity.

Figure 8-34. An image recorded at 9:19:03 a.m. shows the north face of WTC 1. The original has been cropped, rotated, and enhanced. Column and floor numbers have been added.

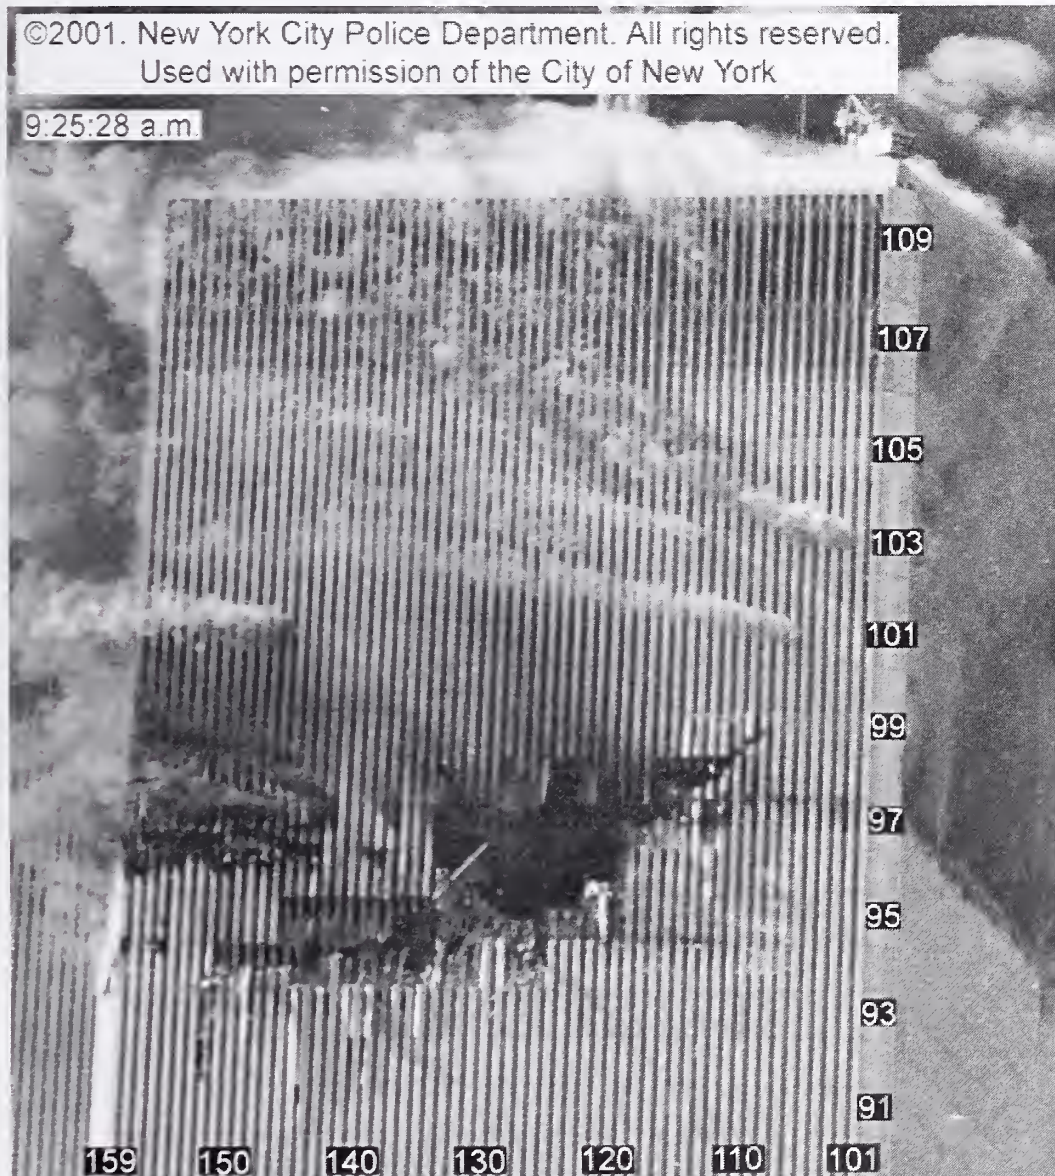
Figure 8–35 shows the north face of WTC 1 as it appeared at 9:25:28 a.m. The amount of smoke coming from the north face, particularly the aircraft impact cavity, has decreased markedly as compared to images taken earlier. There are fires visible on multiple floors, but the amount of smoke coming from these floors is very low. In fact, the densest smoke appears to be coming from open windows that are well above the fire floors. This observation indicates that smoke is still moving upward inside the building and following flow pathways to windows opened by people trapped above the aircraft impact floors. Smoke is still flowing from the air intakes on the 108th and 109th floors.

Figure 8-35. An image recorded at 9:25:28 a.m. shows the north face and an oblique view of the west face of WTC 1. The original has been cropped, rotated, and enhanced. Column and floor numbers have been added.

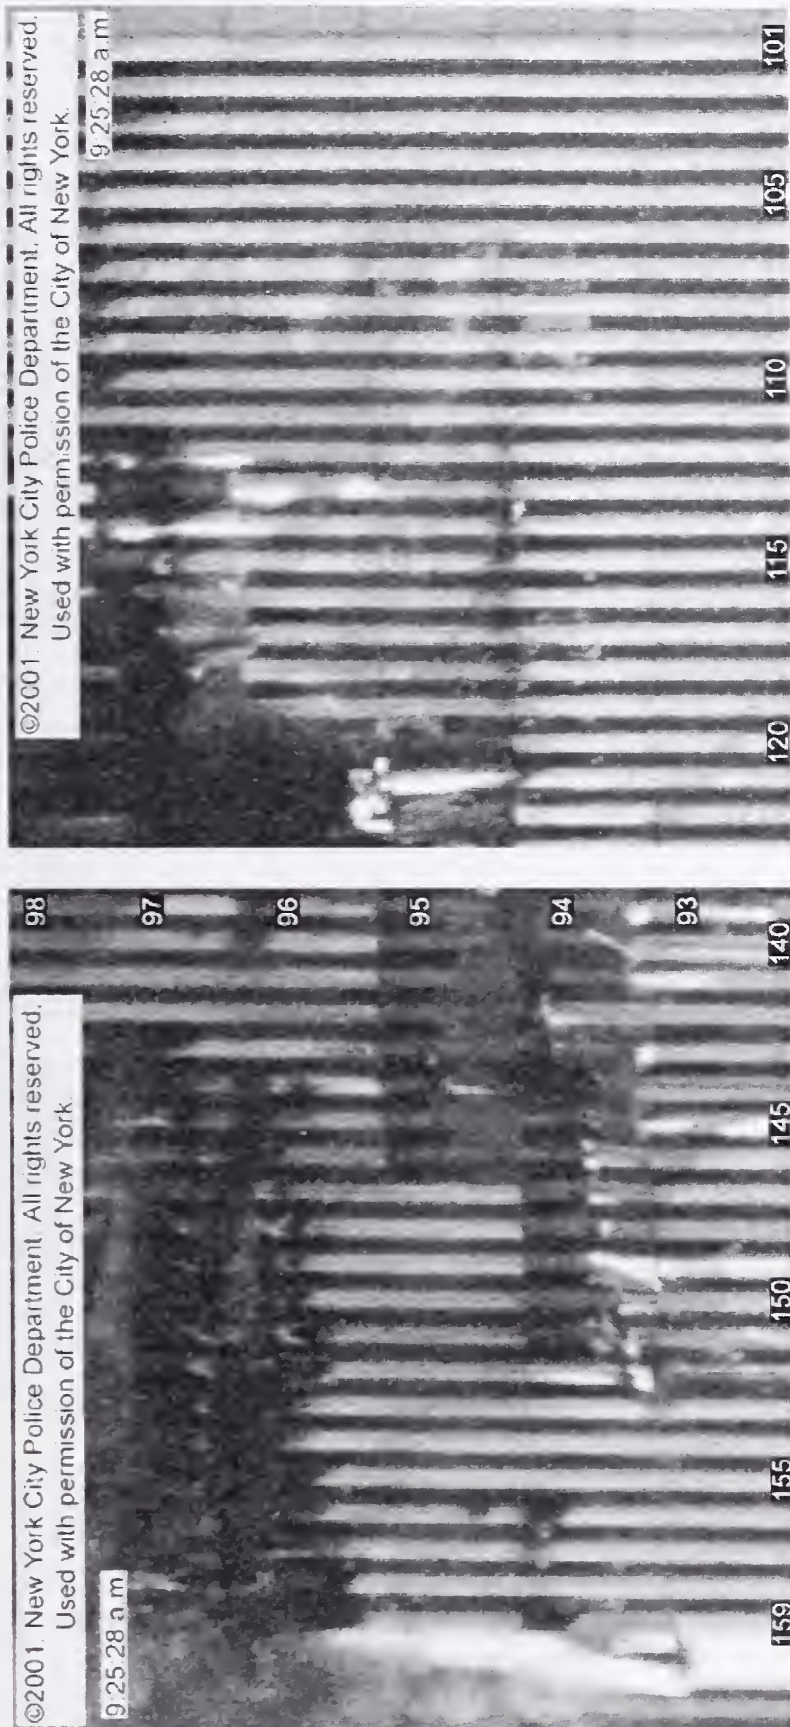
In Figure 8–36 two areas on either side of the aircraft impact cavity in Figure 8–35 have been blown up in order to provide a better view of the active fires. On the east side, fires can be seen on the 93rd, 94th, 96th, and 97th floors. Fires that appear to be relatively small and isolated are present at two locations centered near windows 93-139 and 93-151 on the 93rd floor. On the 94th floor an isolated fire is also present near window 94-151, but the major change from earlier times is that the glass in windows 94-155 to 94-158 is now missing, and an intense fire is evident burning within the building behind the four open windows. Isolated fires are present at the tops of the two windows in the center of the group. Note that the two adjacent windows, 94-153 and 94-154, are still in place. Flames can be seen through multiple open windows on the 96th and 97th floors. There is now no flame extension from the north face windows, and the fires have died down considerably from their levels of a few minutes earlier (e.g., compare with Figure 8–34 recorded at 9:19:03 a.m.).

On the west side of the north face, fire is only visible on the 94th floor. The apparent intensity of this fire has also died down somewhat from a few minutes earlier. The fire has broken into two sections on either side of a central region running from roughly windows 94-109 to 94-113, where only small fires near the bases or tops of the windows are evident. The fire spread to the west has paused at window 94-106, and the five windows to the west have glass in place. This suggests that the fire spread to the west had been slowed down by an internal wall located at column 94-106. The floor plan layout in Figure B-3 indicates that there was indeed an internal wall that terminated on this column.

The areas of the north face of WTC 1 included in Figure 8–36 provide good examples of the correlation of local fire behavior with the column cover marks observed next to windows where fire is present. On the 96th and 97th floors the fires created conditions in which flames extended from the windows. A series of carets are present at the tops of the windows running across these two floors. The heights of the carets vary over the region providing an indication of the local maximum burning intensity. In contrast, fires on the 93rd and 94th floors did not generally extend from windows and did not generate a great deal of smoke flow from the windows. For these windows there were sometimes narrow, dark lines at the tops of the adjacent aluminum column covers, and for others very little marking of the column covers occurred.

An enlarged image of the fires on the west side of the north face is also included in Figure 8–36. The marks on the column covers on the 97th floor show evidence for both types of fires. Those nearest the airplane strike point are marked with carets. Flame extension was observed in this area shortly following the aircraft impact. Further to the west there are black marks above the windows, except for the column covers on either side of window 97-102, which are marked with carets. As discussed earlier, fires on this part of the 97th floor did not extend from these windows for any significant period of time. The same types of narrow black bands are observed at the tops of the columns above the burning region on the 94th floor. Recall that this was a region of heavy burning, but without flame extension.

Figure 8-36. Two blowups from Figure 8-35 of areas on the north face of WTC1 are shown. The photograph was taken at 9:25:28 a.m. The images have been enhanced, and column and floor numbers have been added.

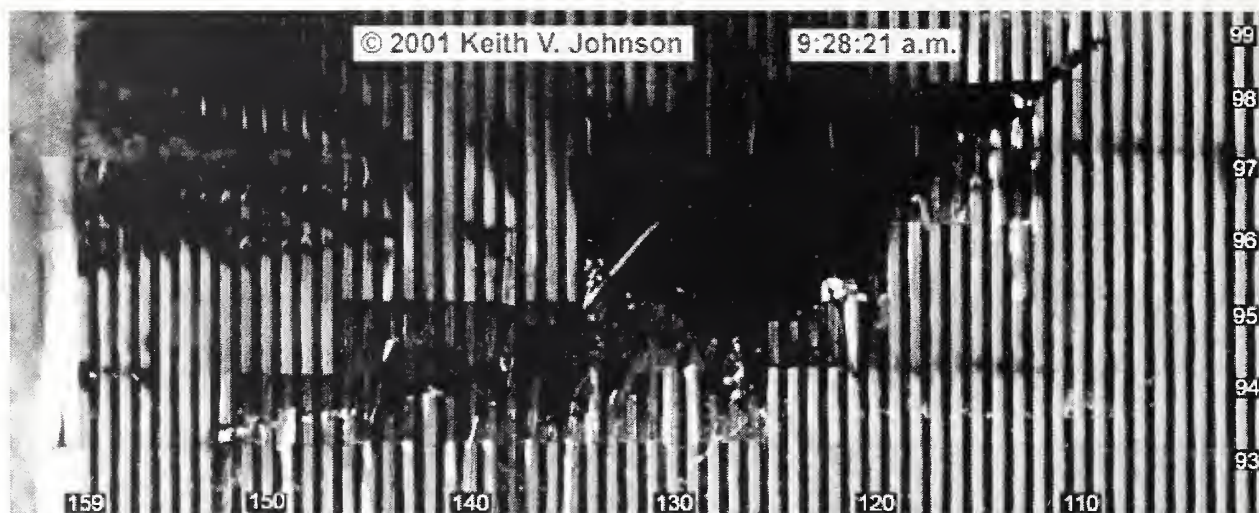
Figure 8-37. This cropped photograph shows the north face of WTC 1 at 9:28:21 a.m. The image has been rotated and enhanced. Column and floor numbers have been added.

Figure 8-37 shows a photograph of the fire floors on the north face taken at 9:28:21 a.m. The fires which grew rapidly at the start of the period are continuing to die down. In particular, the large fires that appeared within the rooms on the northeast corners of the 96th and 97th floors are now barely visible. The fires on either side of the aircraft impact cavity on the 94th floor are also decreasing in size. On the east side there are still fires burning at the window head casings of windows 94-156 to 94-158. An isolated fire can still be seen on the 93rd floor through open windows 93-152 and 93-153.

While it is difficult to make out in Figure 8-37, close inspection shows that there is a small spot fire visible in window 98-123 on the 98th floor. Recall that a similar fire was observed on this floor in window 98-115 around 9:06 a.m. Most windows were still in place on this floor around the time Figure 8-37 was taken.

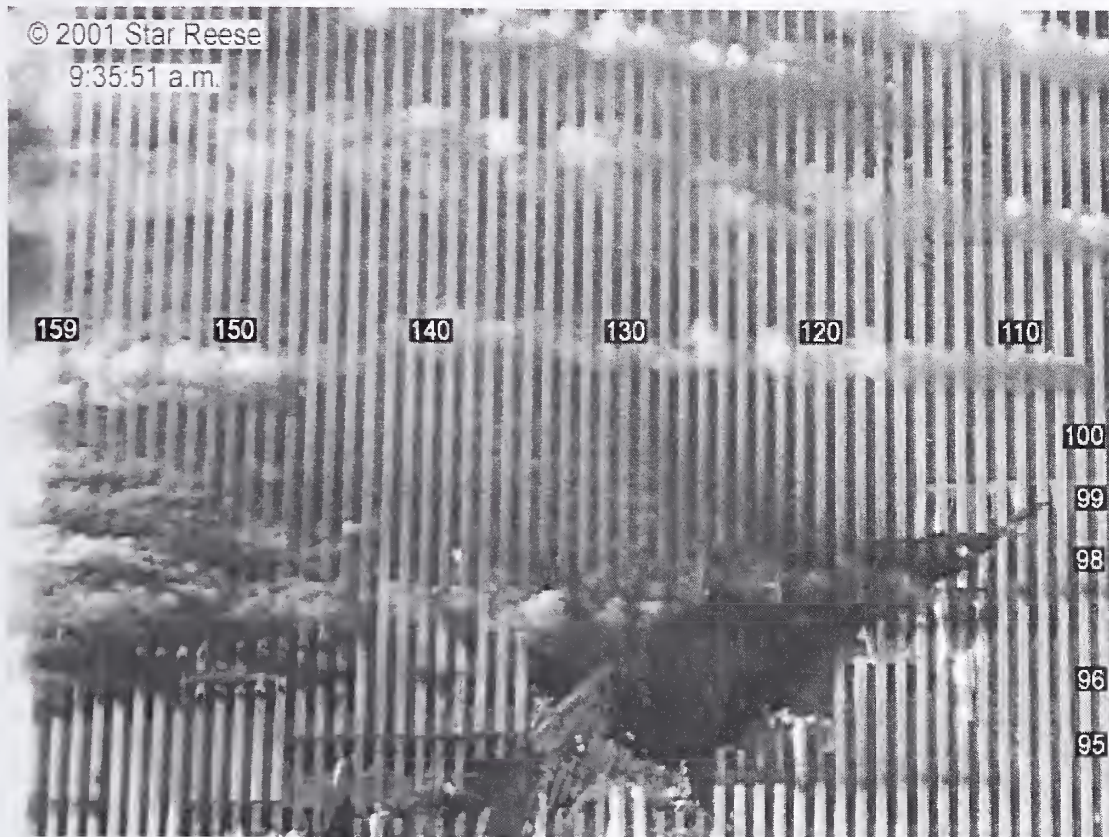
Figure 8-38. A frame taken from a video shows the north face of WTC 1 at 9:35:51 a.m. The image has been enhanced. Column and floor number have been added.

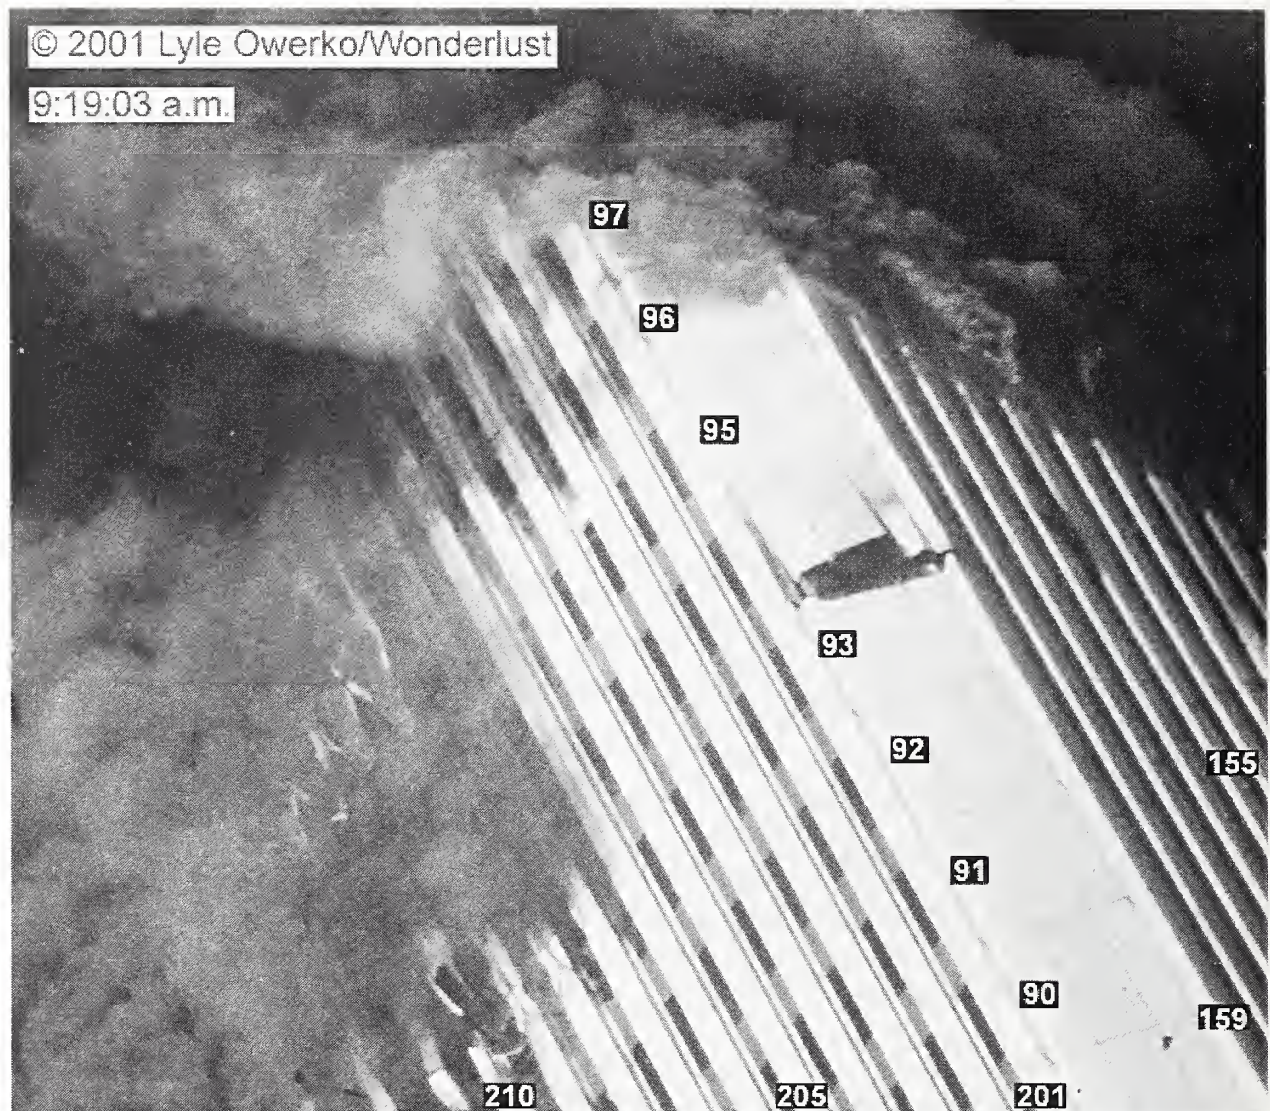
The close-up photograph in Figure 8-39 shows the northeast corner of WTC 1 at 9:19:03 a.m. On the north face, the flames that first emerged from windows on the 96th floor at 9:19:00 a.m. are evident. At the time of Figure 8-39, the largest flame jet was coming from window 96-154. On the east face heavy flames were present in windows 96-208 to 96-211. The distinct carets on the column covers attest to the intensity of the fires that have been burning in the area. The window glass on the inside of the internal wall at column 96-208 is still in place. This is not the case on the 97th floor. Flames are evident through a partially opened window 97-207, indicating that fire had penetrated the wall at column 97-208 by this

time. Recall that fire appeared in windows on the north face at the northeast corner of the 97th floor around this time, but that it was not possible to determine exactly when the windows opened.

Figure 8-39. This cropped close-up photograph showing the northeast corner of WTC 1 was taken at 9:19:03 a.m. It has been enhanced, and column and floor numbers have been added.

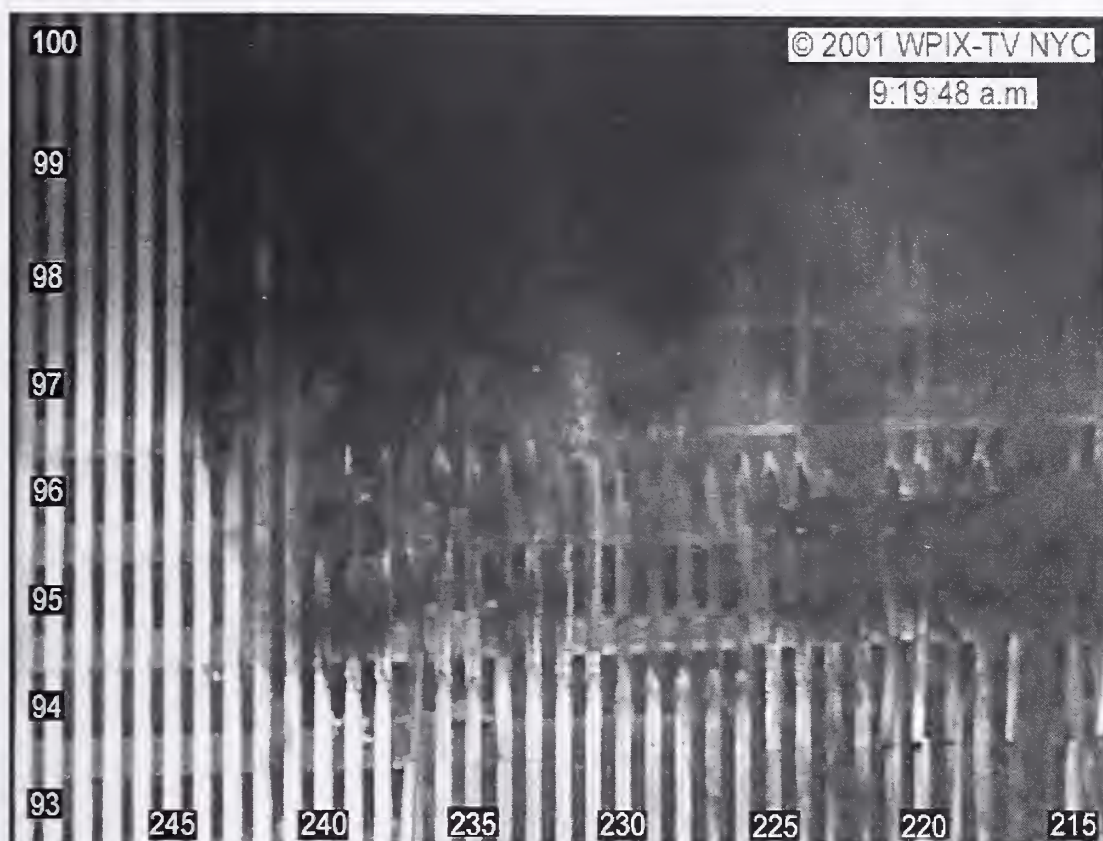
The image in Figure 8-40 was taken from a close-up video showing the central portion of the east face. It was recorded at 9:19:48 a.m. A fire on the 96th floor extends from at least window 96-214 to window 96-233. The fires in the northern part of the photograph on the 96th floor are less intense than those further to the south. When combined with Figure 8-39, this suggests that the fires on the 96th floor are still most intense at either end of the burning area, with an area of dying fire in the center.

Extended flames are coming from window 96-231 in Figure 8-40. The presence of carets indicates that flames had earlier been present at least as far south as window 96-238, but at this time these flames were not visible. The floor plan layout for this floor (see Figure B-5 in Appendix B) does not provide an explanation for this fire distribution, since there are no walls or rooms indicated in this area of the floor.

A region of flame is also evident on the 97th floor, starting near window 97-225 and going west. The full extent of this flaming region is not known, since fire and smoke from the 96th floor hides a portion of these windows. The flames visible on the 97th floor do not extend from windows and appear to be dying down.

There are no extensive flame regions evident on the 93rd or 94th floors. A review of videos recorded around this time indicates that the fires on these floors had indeed died down. Smoke is visible coming from below in Figure 8-40. This smoke is coming from the 92nd floor.

Figure 8-40. A frame taken from a video shows a portion of the east face of WTC 1 at 9:19:48 a.m. The image has been enhanced, column and floor numbers added.

There are some interesting variations in the column smoke markings in Figure 8-40. In particular, consider the 94th floor. Many of the column covers have distinct carets that are characteristic of locations next to windows that have experienced extended flames. Clear examples of carets can be seen on the covers for columns 94-226 to 94-230. On other column covers the smoke marks take the form of alternating horizontal bands of light and dark areas. The marks on the covers for columns 94-231 to 94-234 show good examples of this type. By comparing the markings with the local fire behavior, it has been possible to correlate the formation of this type of smoke mark with windows from which there had been a heavy smoke flow, but for which external flaming was not observed. In contrast to the mixed fire behavior seen on the 94th floor, carets are present on nearly all of the columns on the 96th floor visible in Figure 8-40.

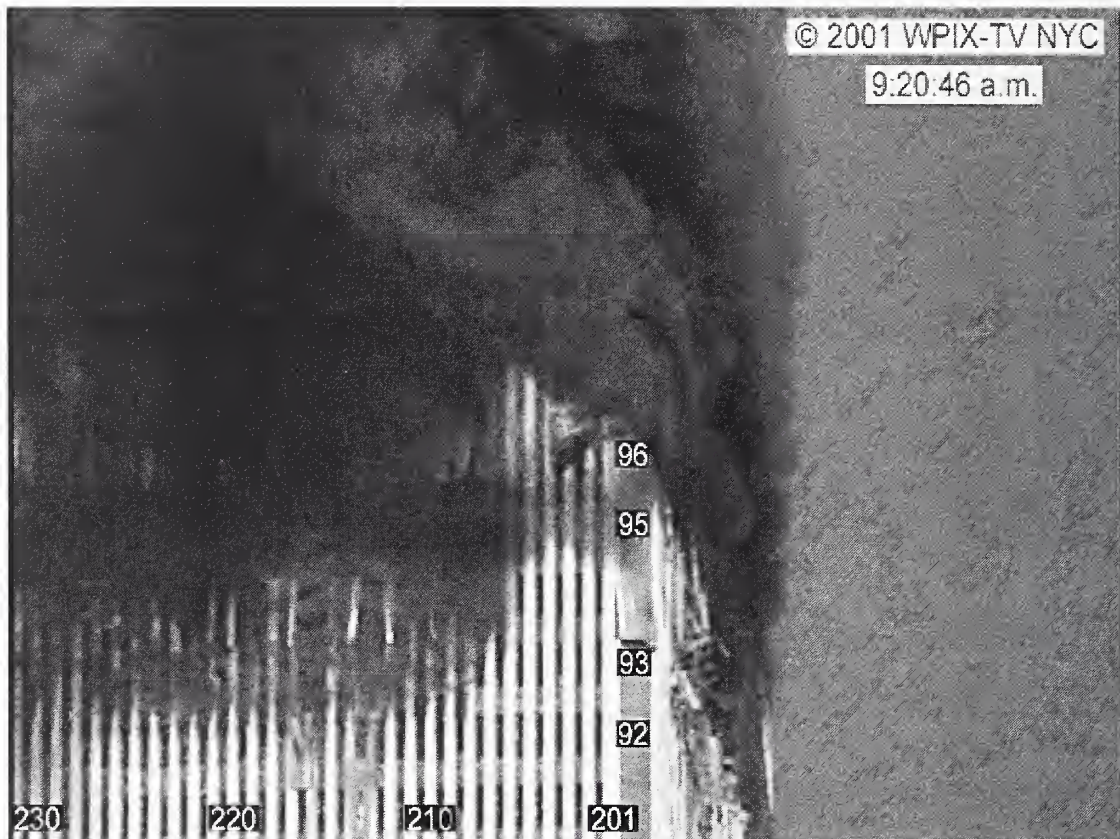
At 9:20:45 a.m., window 96-203 at the northeast corner of the 96th floor opened, and heavy smoke began to pour out. This was followed almost immediately by external flaming. Figure 8-41 is a frame taken from a video showing the appearance of this flame one second later, at 9:20:46 a.m. It has been nearly 75 s since the last window on the north side of the rectangular room in the northeast corner of this floor opened. The wall for this room on the east face is located at column 96-204 (see Figure B-5), i.e., next to the window on the east side of the room that first opened.

Figure 8-41. A frame taken from a video shows a portion of the east face of WTC 1 at 9:20:46 a.m. The image has been enhanced. Column and floor numbers have been added.

In Figure 8-41 heavy smoke is flowing from a number of windows on the 92nd floor, starting at window 92-208 and running to the last visible window, 92-230. A dull orange glow is evident in the vicinity of windows 92-214 to 92-218, but the remaining open windows appear to be dark. Shortly after Figure 8-41 was shot, the video zoomed out, revealing that internal fires were present inside the tower at least as far south as window 92-234, with open windows as far as window 92-237. Figure 8-22, which was taken at 9:15:54 a.m., showed internal fires in this same area. During the intervening period, the fire had moved north one window, having opened window 92-208. There is no obvious reason for the fire spread to slow down at this location, since the floor plan layout in Figure B-2 in Appendix B indicates there was not a wall at column 92-208. At 9:15:54 a.m. the fire had already moved as far south as window 92-234. During the next five minutes, three additional windows were opened. Fire spread in this direction also appears to have been retarded. The floor plan layout for this floor does indicate that there was a wall located at column 92-238, i.e., right next to open window 92-237. Detailed drawings for this floor show

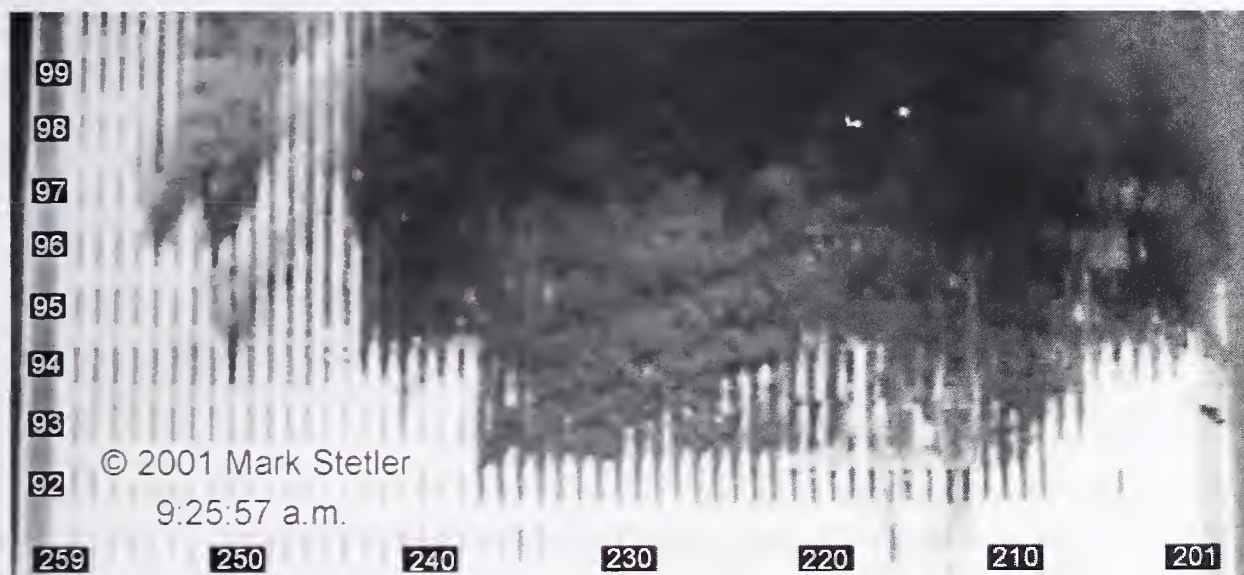
Figure 8-42 is a photograph of the east face taken at 9:25:57 a.m. The flames which had earlier spread into rooms located on the northeast corners of the 94th and 96th floors are still burning intensely. There is also now a large fire burning in the northeast corner room on the 97th floor. It has not been possible to identify exactly when this fire appeared because smoke and fire from the 96th floor hid its development from view. However, a video taken near 9:23:30 a.m. shows that flames were coming from window 97-203 at that time, so it must have appeared between 9:20:45 a.m., when fire was first visible in the area on the 96th floor, and this time.

Figure 8-42. This cropped photograph shows the east face of WTC 1 at 9:25:57 a.m. The image has been rotated slightly and column and floor numbers have been added.

Fire is evident at a couple of locations on the 93rd floor. It appears as if flames are present inside window 93-206, while adjacent windows to the north still have glass in place. Recall that window 93-206 was already open at 9:19:03 a.m. (see Figure 8-39) and that fire spread to the north had seemed to pause at this location prior to this. The observations continue to suggest the presence of a room in the northeast corner of this floor with a wall at column 93-206, even though the incomplete floor plan layout in Figure B-2 does not allow this to be confirmed.

The exhausting smoke and flames visible in Figure 8-42 indicate the presence of an active fire on the 94th floor at windows 94-238 to 94-244. Fire in this region was not evident roughly six minutes earlier when the image in Figure 8-40 was recorded. The pause in fire spread on the 94th floor suggests that the fire had been temporarily blocked by a wall. It is not clear that this was the case since, even though there was a wall connecting column 94-238 to the core (see Figure B-3 in Appendix B), this is not the exact location where the fire paused. As early as 9:15:54 a.m. (see Figure 8-22) there was evidence that the fire had spread as far as window 92-240 on the east face. This is one of the few examples identified thus far where a spreading fire did not appear to pause immediately outside of a known existing wall. It is possible that this wall was breeched during the aircraft impact, since there was minor façade damage on the 94th floor in this quadrant on both the east and south faces. However, this does not provide an explanation for the reduced rate of fire spread after the fire had passed through the wall.

In Figure 8-42 fires are visible between windows 96-230 and 96-240 on the 96th floor and windows 97-230 and 97-240 on the 97th floors. This indicates that the fires on these floors are continuing to spread toward the south.

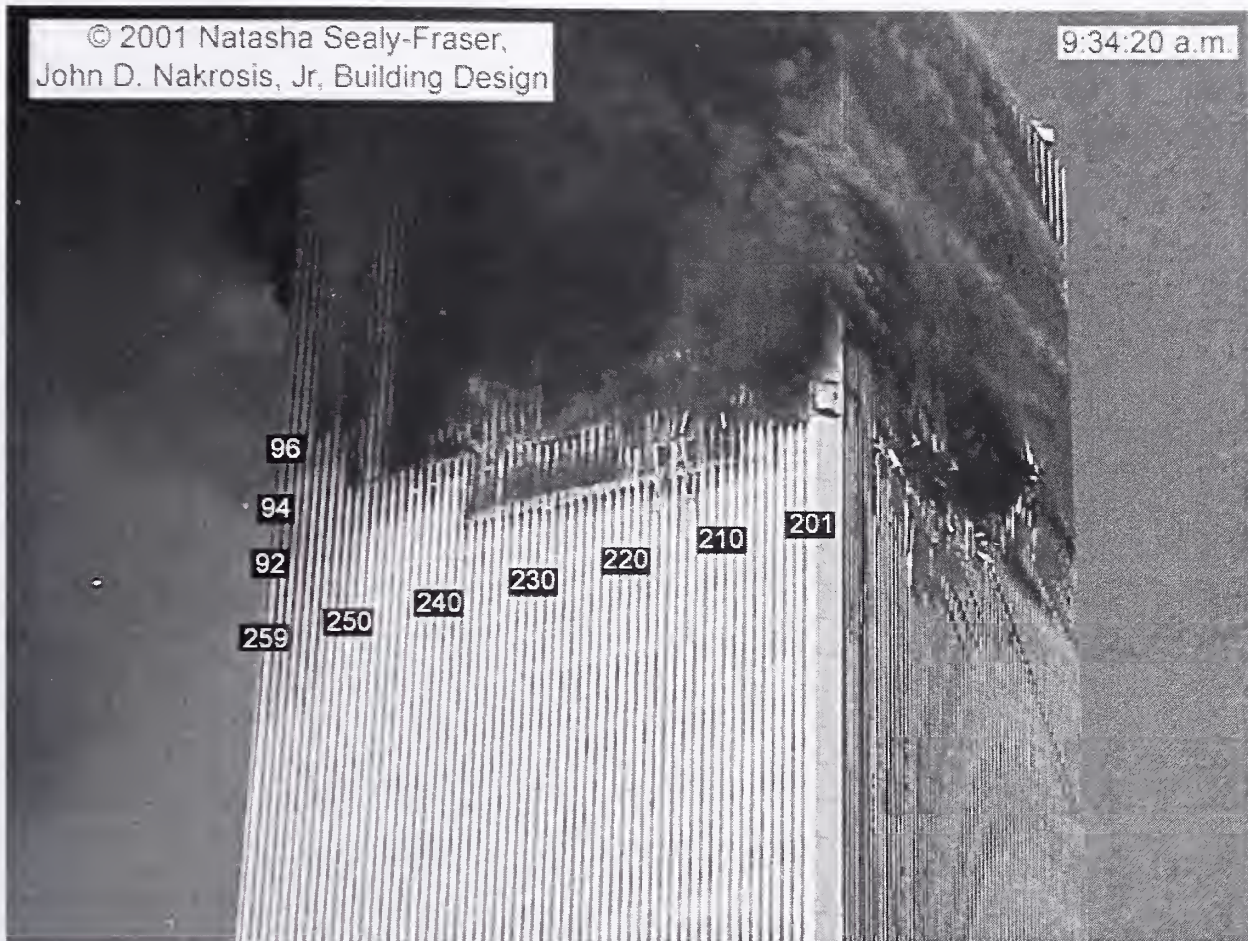
At 9:32:58 a.m., smoke emerged from the northeast corner of the 93rd floor at window 93-205. During the next 31 s, the successive windows toward the north opened, reaching window 93-201. At this time, 9:33:29 a.m., flames appeared in the area. Figure 8-43 shows a photograph of the east face recorded at 9:34:20 a.m. From this angle and distance, only flames extending from windows are apparent. Flames are coming out of windows 93-201 to 93-205. The sudden fire development and flame extension from windows is a strong indication that flashover has occurred within an enclosed space located around windows 93-201 to 93-205. The evidence for an enclosed space with walls that hindered fire spread into the northeast corner of the 93rd floor is quite strong even though the presence of such a room cannot be confirmed from the incomplete floor plan layout shown in Figure B-2.

Intense flaming was also taking place on the 96th floor near windows 96-236 and 96-237. Much more of the façade is now visible through the smoke than earlier. In particular, this is an indication that fires on the 92nd floor and 94th floor, which were generating large quantities of smoke at earlier times, have largely died down.

Figure 8-43. Photograph of the east face of WTC 1 recorded at 9:34:20 a.m. Column and floor numbers have been added.

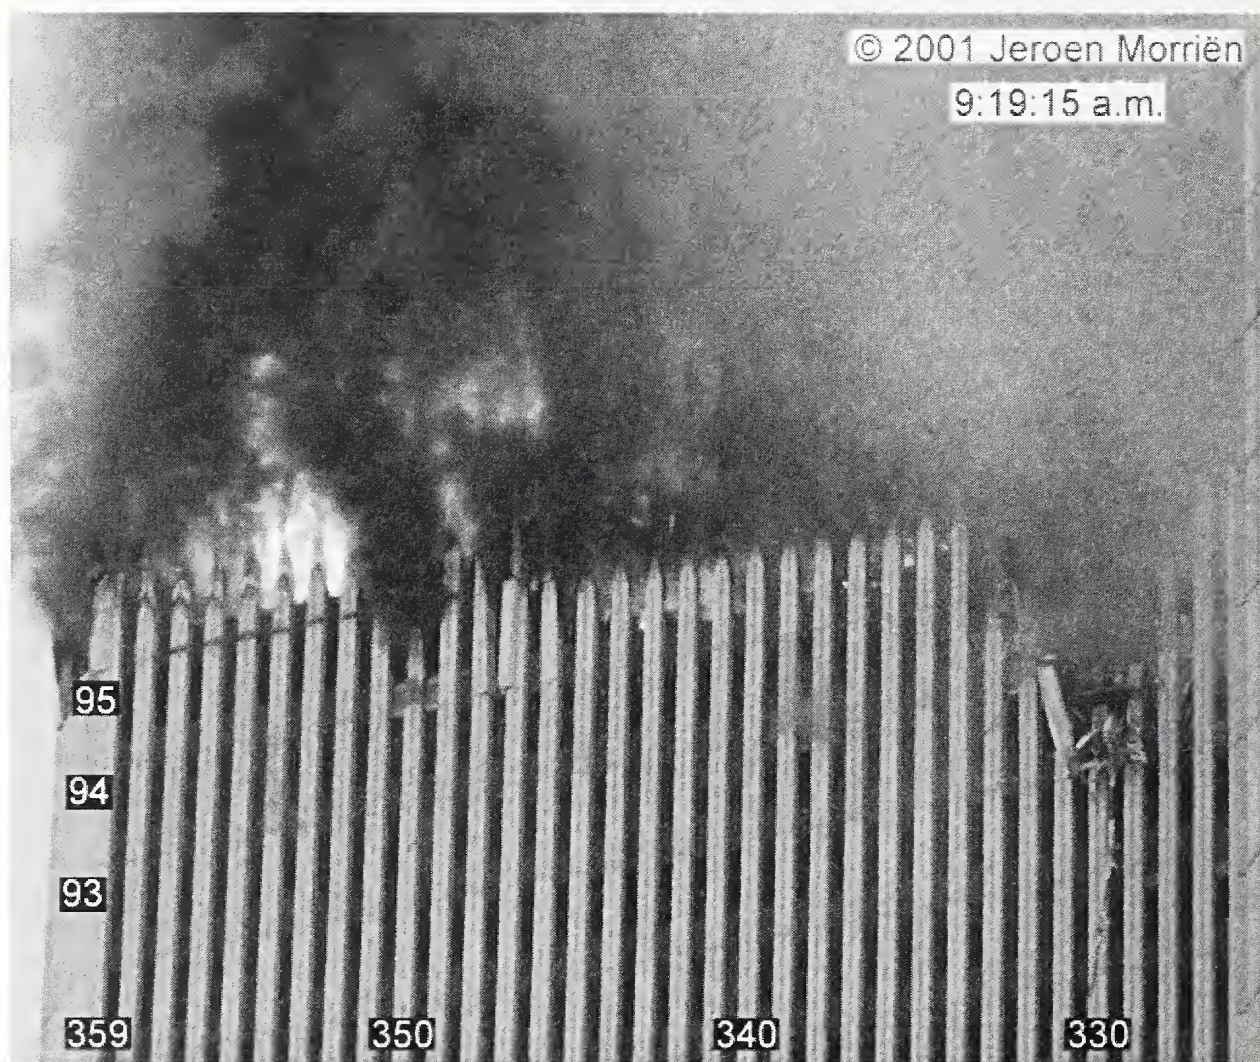
Figure 8-44 provides a view of the south face at 9:19:15 a.m. The general appearance of the fires is little changed from that in Figure 8-27, which was recorded near 9:16:40 a.m. The intense jets of flames coming from windows 96-352, 96-353, and 96-354 on the 96th floor remain a prominent feature. This image provides a particularly good view of the area on the 93rd floor, near column 330, where the steel panel section, which was found near the corner of Cedar and West Streets, is believed to have originated. Extensive damage is evident in the vicinity, but it is not possible to visually confirm that the section is actually missing. There is a long section of what appears to be a pipe hanging below the suspected opening that appears to be attached to a cylindrical object. Recall that a long section of pipe was seen in photographs of the detached panel section lying in the street (see Figure 6-16 and Figure 6-17). The presence of piping near the suspected origin for the panel section provides further support that the panel section actually did come from this spot.

Figure 8-44. This cropped image shows a portion of the south face of WTC 1 at 9:19:15 a.m. The photograph has been enhanced and column and floor numbers have been added. The corner of WTC 2 is visible at the far right side of the image.

A line of deposited soot is visible at the top of columns 95-351 to 95-357 at the western side of the 95th floor. These markings can be seen more clearly in Figure 8–44. No smoke is apparent coming from the windows, and it appears likely that the glass is still in place for these windows. The formation of these marks may be an indication that fire gases and smoke were leaking from the tower at locations where windows still had intact glass. Presumably, the leaks took place through the expansion joints located between column covers on different floors.

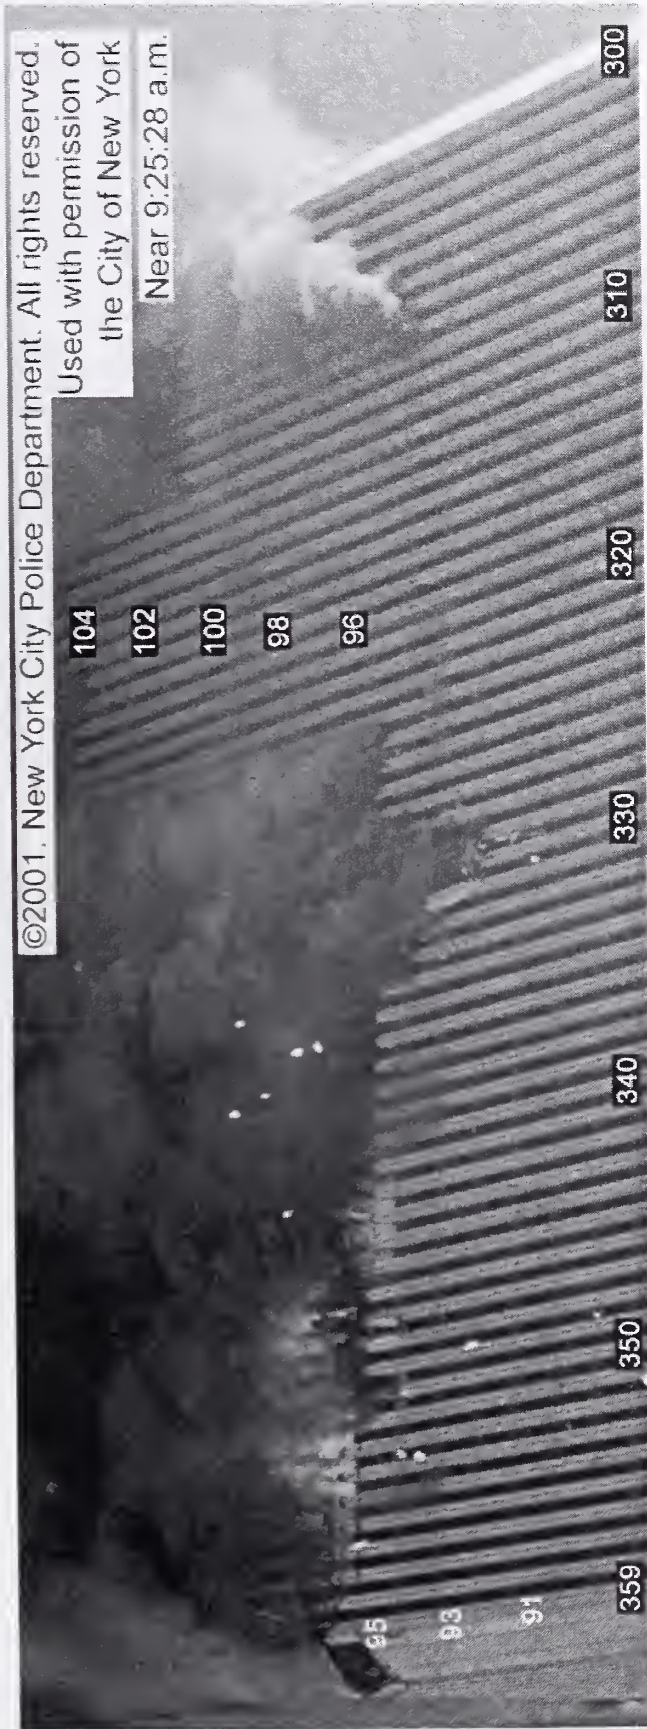
A later view of the burning area on the south face is shown in Figure 8-45, which was recorded around 9:25:28 a.m. There are a large number of pages of paper visible in the photograph. A video of the west face showed that these pages had traveled from the west face of the tower, where they had been released from an upper window. The fires present at this time remain quite intense and extensive, but there have been some changes since 9:19:15 a.m. The fires at the western edge of the 96th floor appear to be dying down and have receded back into the windows, while the strong jets of flame evident in Figure 8-44 on this floor are not as distinct. The fires on the 95th floor appear to have grown stronger. There is now flame extension from windows 95-340 to 95-343. The flames near the center of the face indicate that the fires on either the 96th floor or 97th floor, or both, extend continuously from the west edge of the south face to very near the center, i.e., column 330.

Figure 8-45. This cropped photograph shows the south face of WTC 1. It was taken around 9:25:28 a.m. with an assigned time uncertainty of 15 seconds. The original image has been enhanced and rotated. Column and floor number have been added. A number of pages of paper are present in the photograph.

Even though fires have been burning on the south face for well over a half hour, there is no indication in Figure 8–45 that the flames have begun to spread toward the east. With the exception of broken windows on floors well above the fire, the appearance of the east side of the façade has not changed since the aircraft impact.
